**Flood Control Project Maintenance
Levee Inspections**

Fall 2010 Levee Maintenance Deficiency Summary Report

Levee Inspection Report By Mile - Fall 2010

Solano County Public Works Mellin Levee

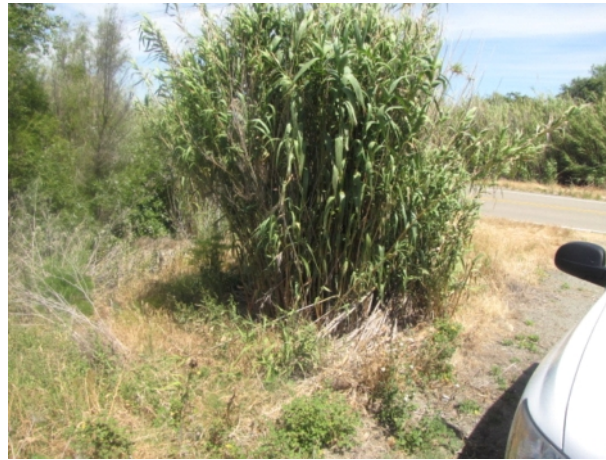
richard_f_20100921_029.jpg

Levee Mile Report Line	1
Start Levee Mile	0.00
End Levee Mile	0.00
Location	Water Side
Category	Earthen Levee
Item	Vegetation

Looking northeast at bamboo on waterside at the entrance to levee.

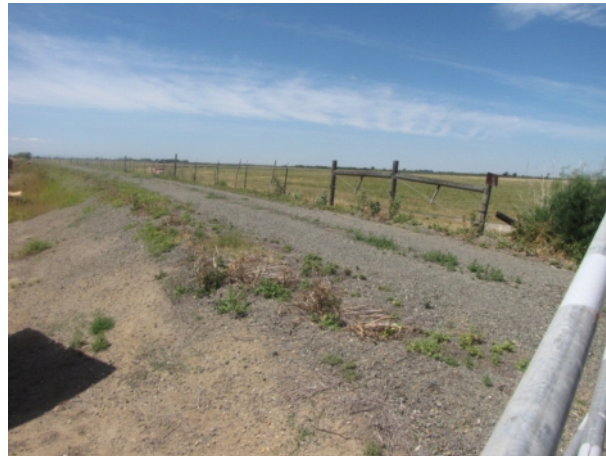
richard_f_20100921_030.jpg

Levee Mile Report Line	2
Start Levee Mile	0.00
End Levee Mile	0.59
Location	Water Side
Category	Earthen Levee
Item	Encroachments

Fence along the waterside shoulder.

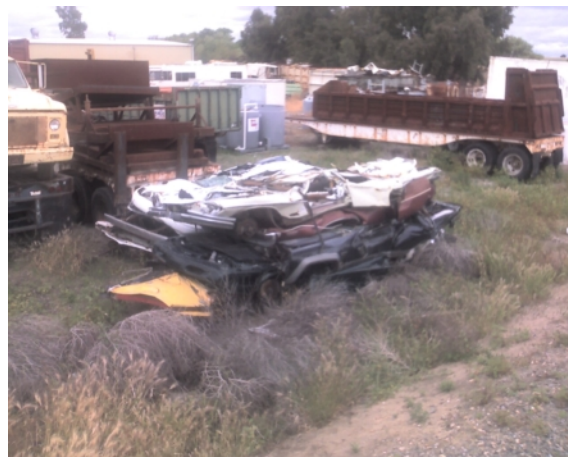
richard_f_20100921_031.jpg

Levee Mile Report Line	3
Start Levee Mile	0.04
End Levee Mile	0.04
Location	Land Side
Category	Earthen Levee
Item	Encroachments

Looking southwest at dilapidated vehicles on landside toe.

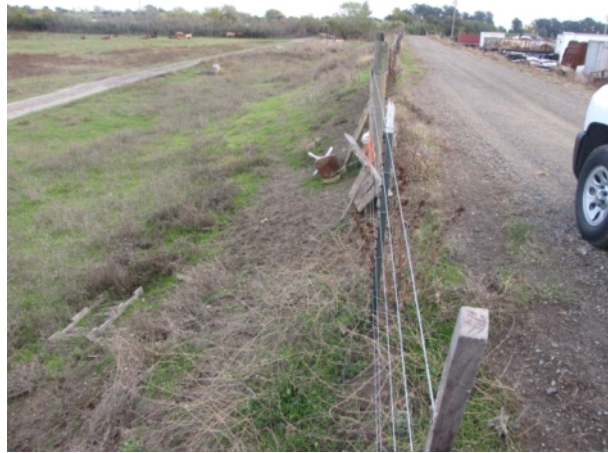
richard_f_20101123_466.jpg

Levee Mile Report Line	4
Start Levee Mile	0.08
End Levee Mile	0.08
Location	Water Side
Category	Earthen Levee
Item	Slope Stability

Looking downstream (east) at slope damage on waterside slope and shoulder.

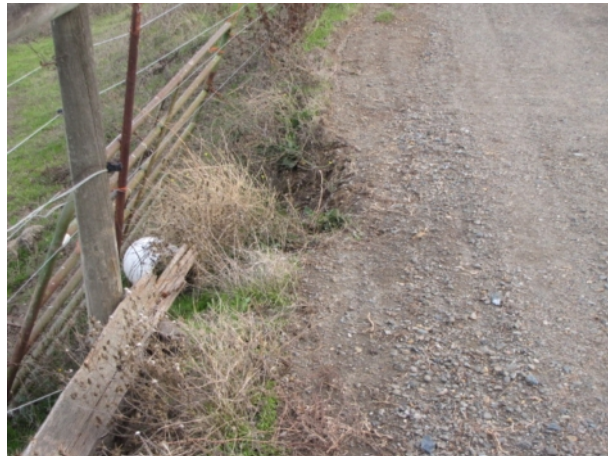
richard_f_20101123_467.jpg

Levee Mile Report Line	4
Start Levee Mile	0.08
End Levee Mile	0.08
Location	Water Side
Category	Earthen Levee
Item	Slope Stability

Looking east at slope damage on waterside shoulder.

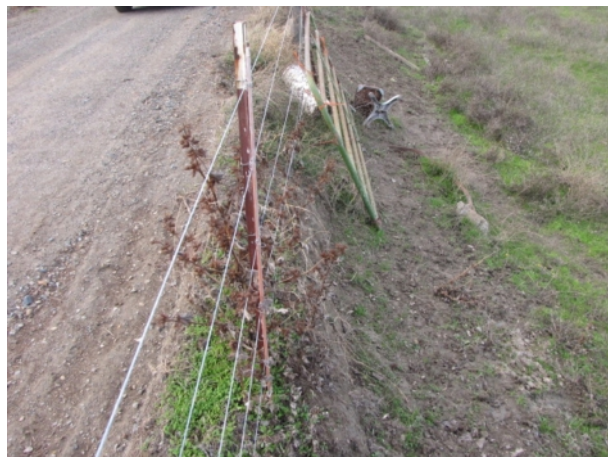
richard_f_20101123_468.jpg

Levee Mile Report Line	4
Start Levee Mile	0.08
End Levee Mile	0.08
Location	Water Side
Category	Earthen Levee
Item	Slope Stability

Looking upstream (west) at slope damage on waterside slope and shoulder.

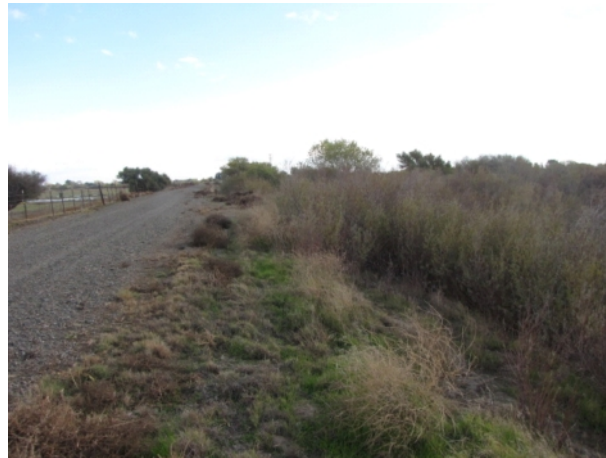
richard_f_20101123_464.jpg

Levee Mile Report Line	7
Start Levee Mile	0.44
End Levee Mile	0.47
Location	Land Side
Category	Earthen Levee
Item	Vegetation

Looking downstream at dense vegetation on landside slope & toe.

7	0.44	0.47	Earthen Levee	Vegetation	LS	M	Remove the wild growth other than native grasses from the levee slopes.	38.178530 ° -121.679993 °	38.178834 ° -121.680388 °	7 Y

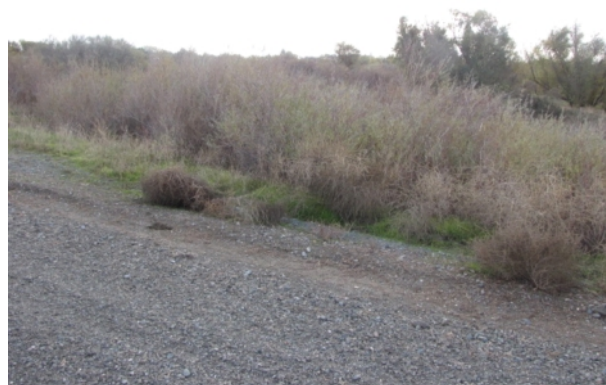
richard_f_20101123_465.jpg

Levee Mile Report Line	7
Start Levee Mile	0.44
End Levee Mile	0.47
Location	Land Side
Category	Earthen Levee
Item	Vegetation

Looking south at dense vegetation on landside slope and toe.
